Manhole Inspection Summary

Manhole # S13QQ1023MH

Location Address: **2807 OAKLEY AVE**

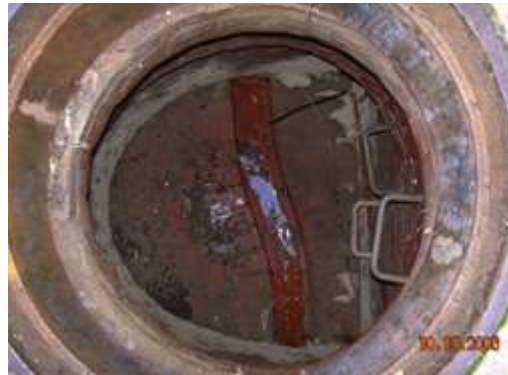
Top View

Offset: **2** (in.)

Frame offset. Bench debris.

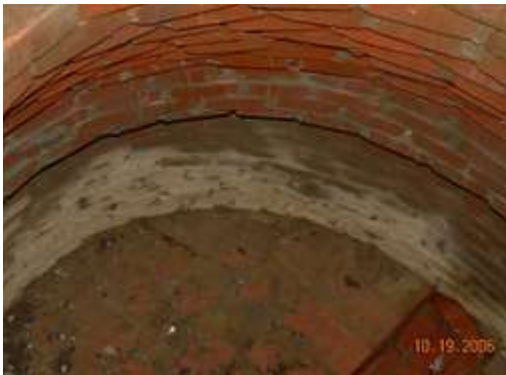
Defect

Condition: ☐ Sound ☐ Cracked ☐ Root Intrusion ☐ Loose Brick ☒ **Deteriorated**

Infiltration: ☐ None ☒ **Joint** ☐ Cracks ☒ **Mortar** ☐ Roots ☐ Wall

Barrel infiltration.

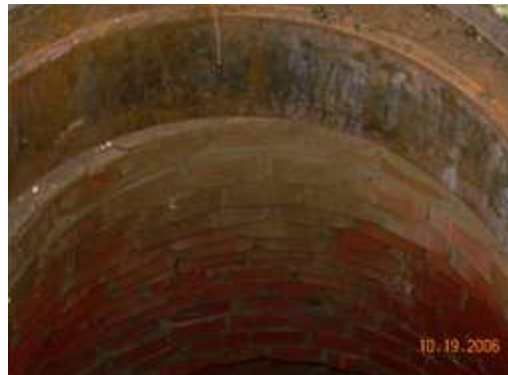
Defect

Condition: ☐ Sound ☐ Cracked ☐ Root Intrusion ☐ Loose Brick ☒ **Deteriorated**

Infiltration: ☐ None ☒ **Joint** ☐ Cracks ☒ **Mortar** ☐ Roots ☐ Wall

Adjustment deterioration and infiltration.

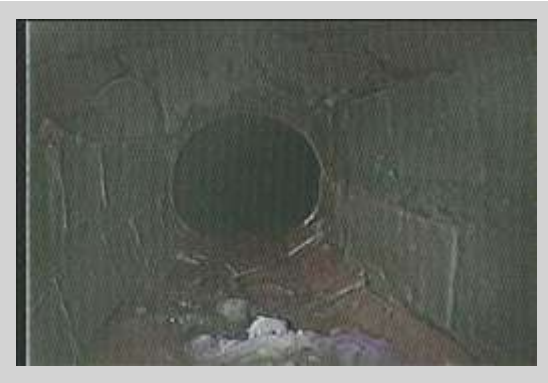
8 in. Circular Gravity Sewer Pipe Out @ 12 O'Clock

Barrel and Channel deterioration.

Infiltration: **Evidence** Pipe Seal Cond: **Cracked**

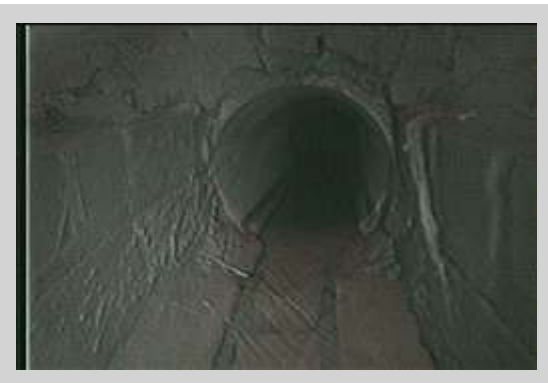
8 in. Circular Gravity Sewer Pipe In @ 6 O'Clock

Infiltration: **Evidence** Pipe Seal Cond: **Cracked**
